Paradiso G.; Del Piñal Pellón M.; Soler Vázquez A.; Peláez Rico J.; Suárez García MJ.  
Master of Prosthodontics and Occlusion, Complutense University of Madrid.

In recent years, the increasing aesthetic demand and the evolution of digital systems and CAD-CAM technology have favoured research and development of new ceramic materials. Resin-matrix ceramics (RMC) have recently been introduced, a material that simulates the modulus of elasticity of dentine and it's easy to repair. The aim of this study was to evaluate survival, success rate and mechanical and biological complications of resin-matrix ceramic printed posterior crowns in a full digital flow.

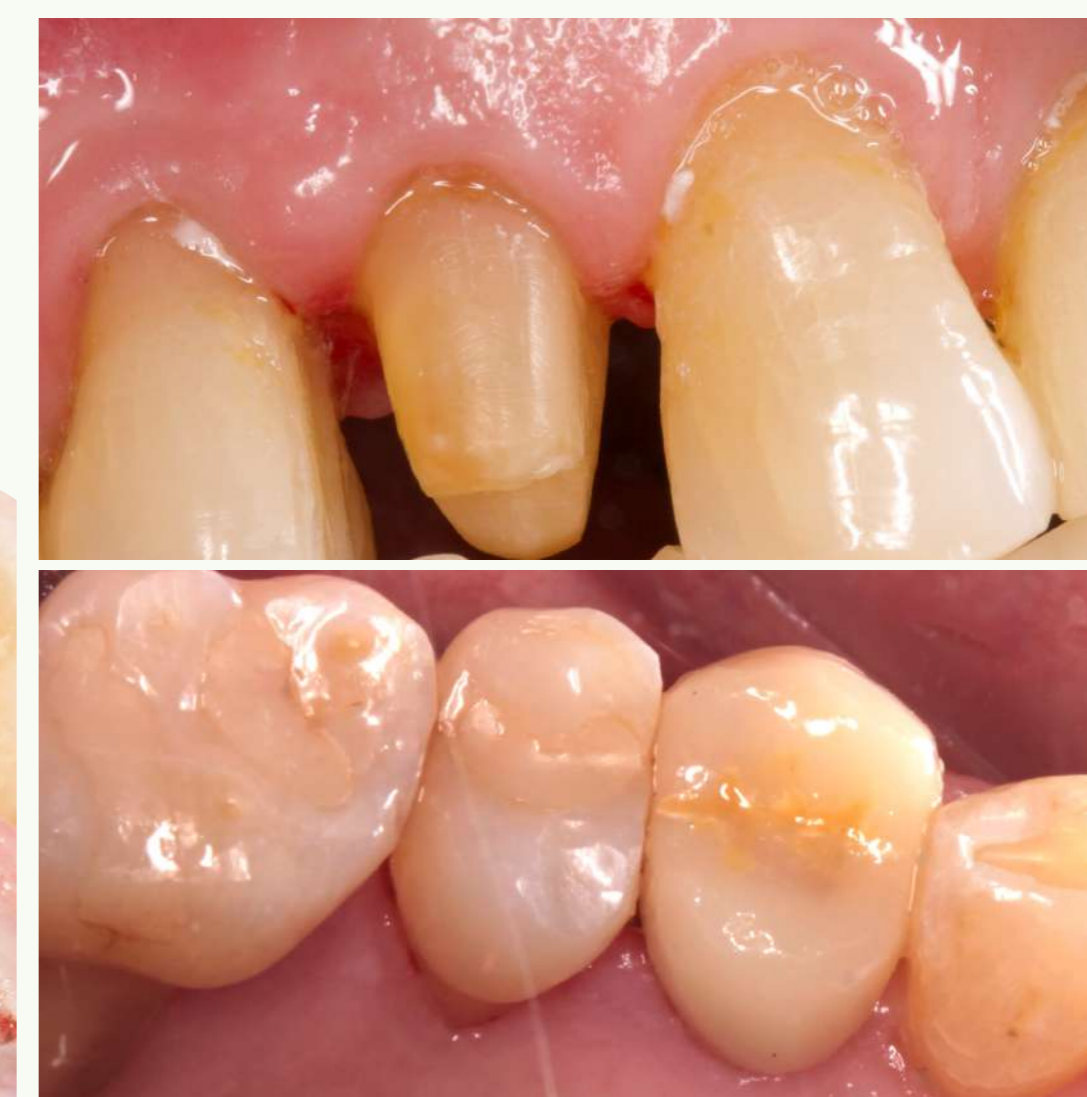
Fig. 3,4: Tooth preparation with 1mm chamfer.

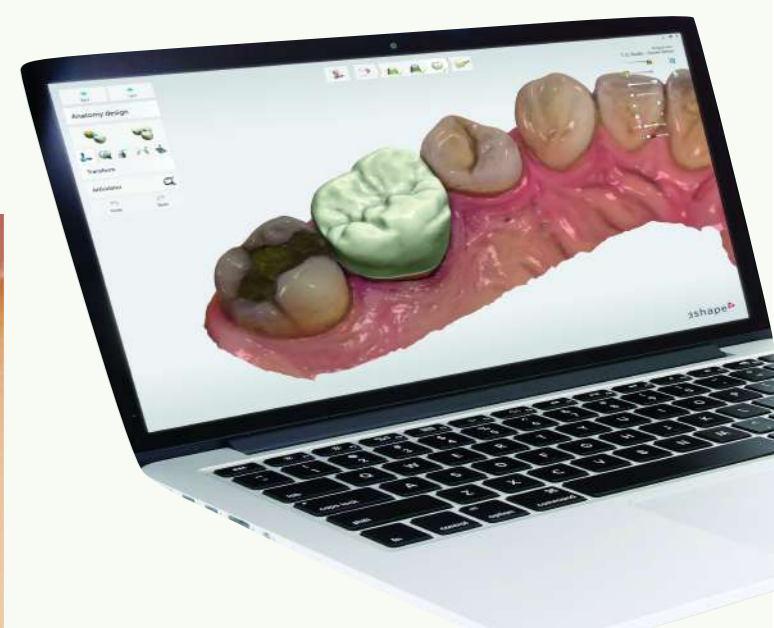
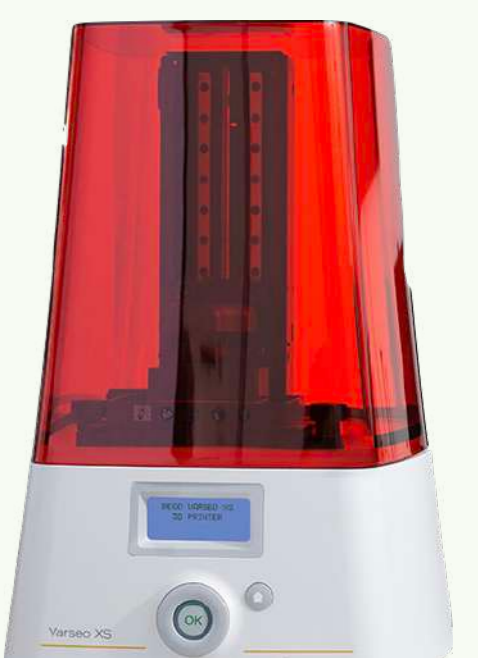
Fig. 5,6: 1.4 prepared and cemented.

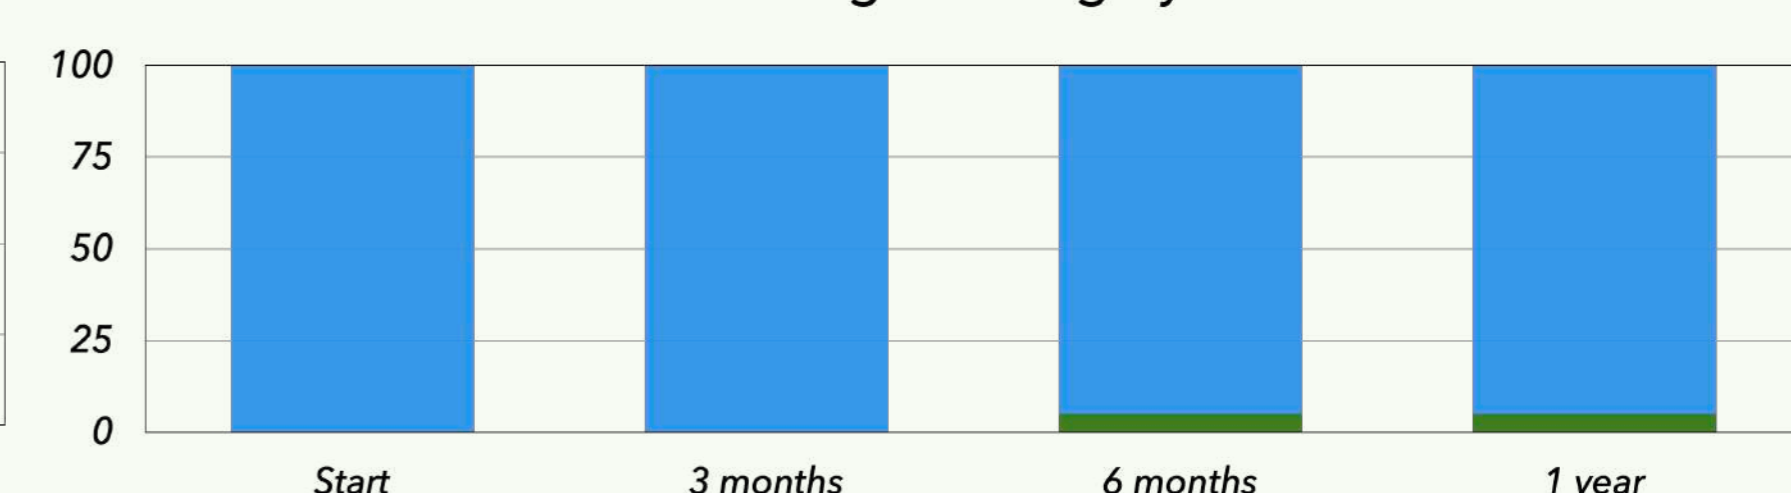
Marginal Integrity

Replacement Repair Acceptable Excellent

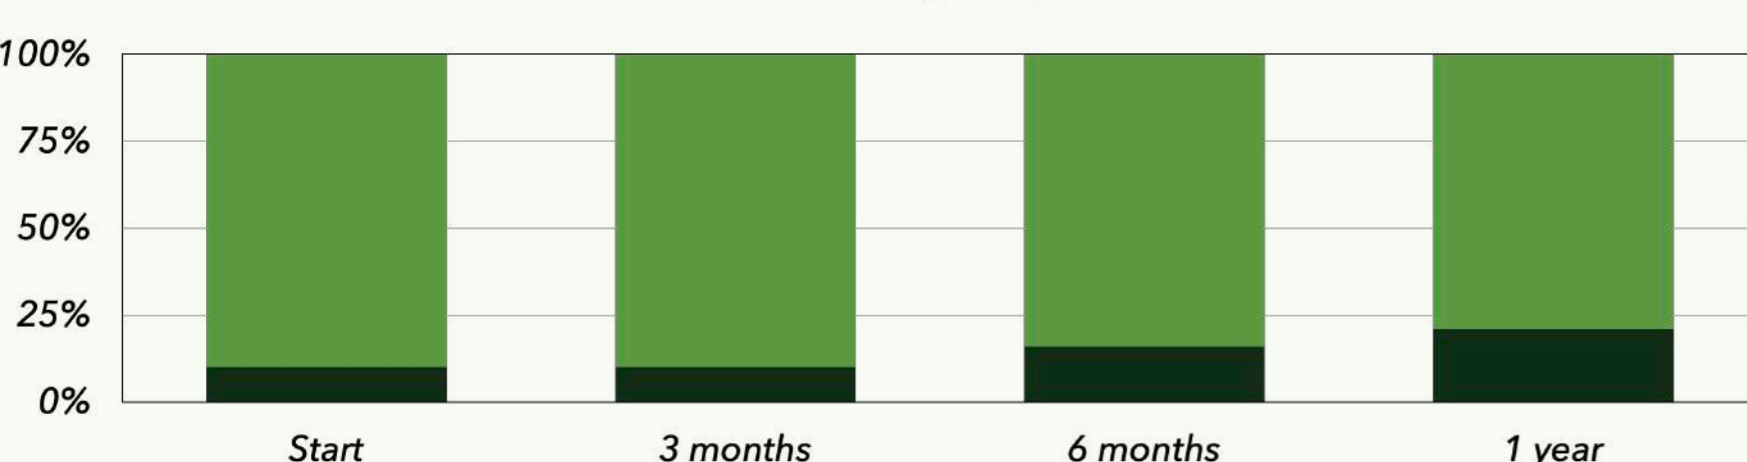
Probing Depth

1 <3mm 2 3 >9mm 4

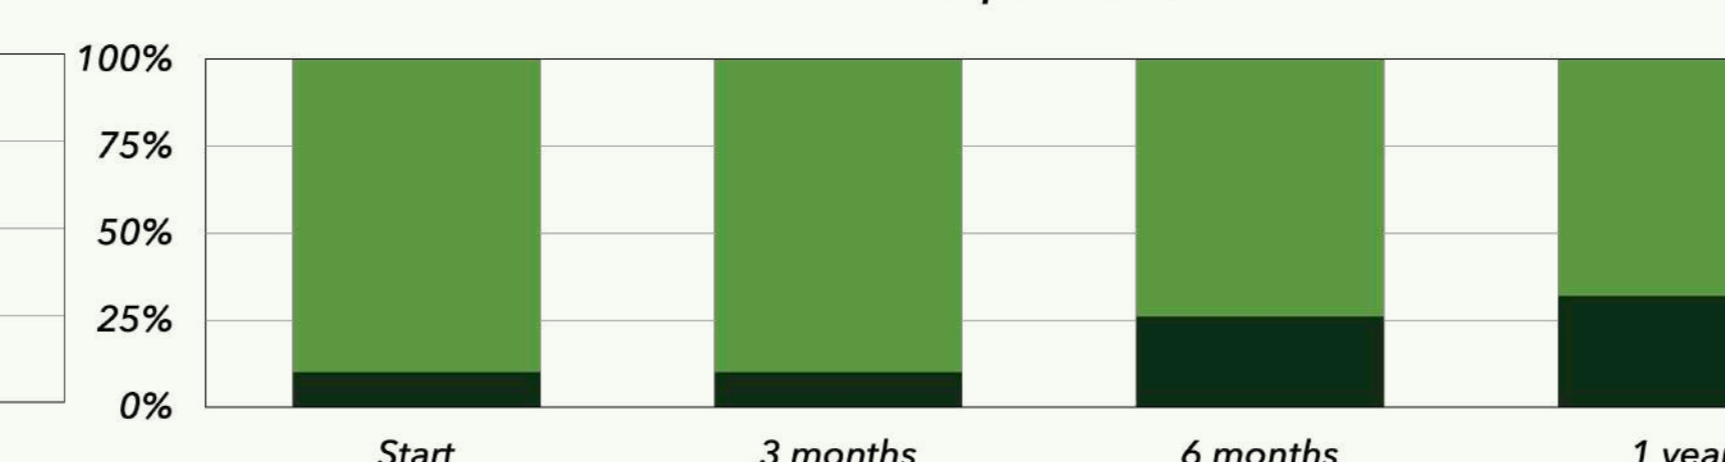
Plaque Index

0 No plaque 1 2 3 ↑ Plaque

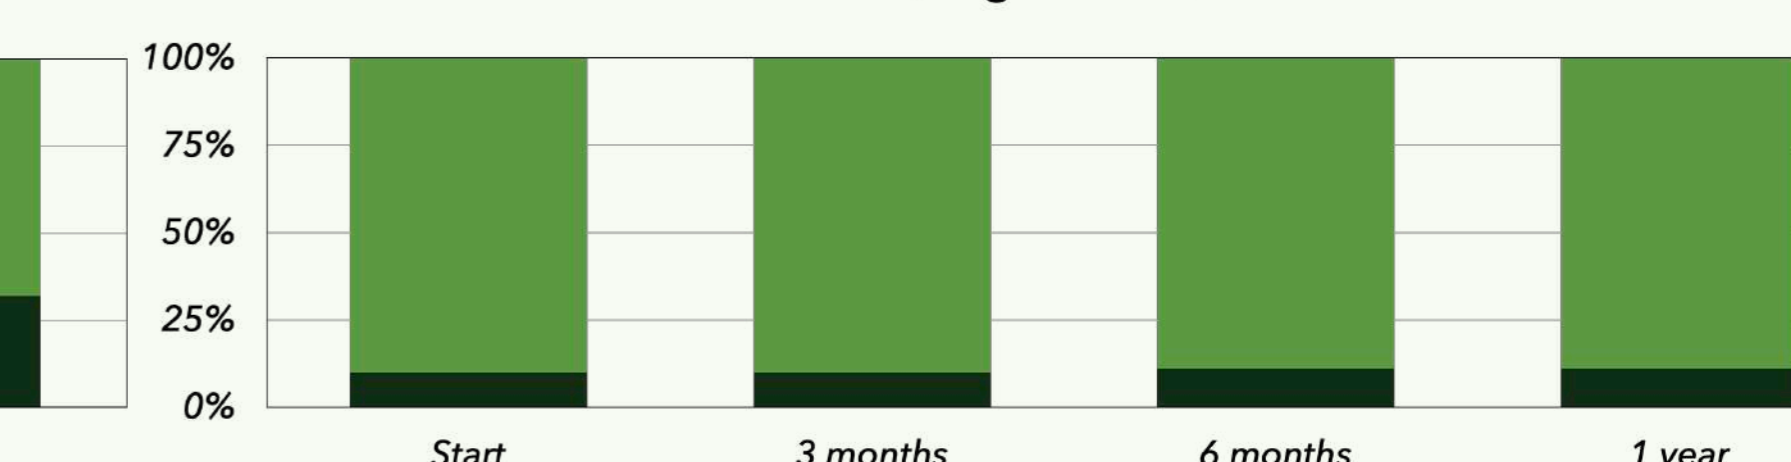
Gingival Index

0 Normal 1 2 3 Bleeding
