A Prosthetic Solution that Conforms with Nature: Different Materials, Single Goal

The article presents technical-clinical procedures adopted for a prosthetic solution that conforms with nature, using coordinated clinical procedures and many technical procedures carried out with the aid of different metalfree materials for the fabrication of prosthetic restorations, specifically Zirconium Dioxide (Zirconia) and Lithium Disilicate.

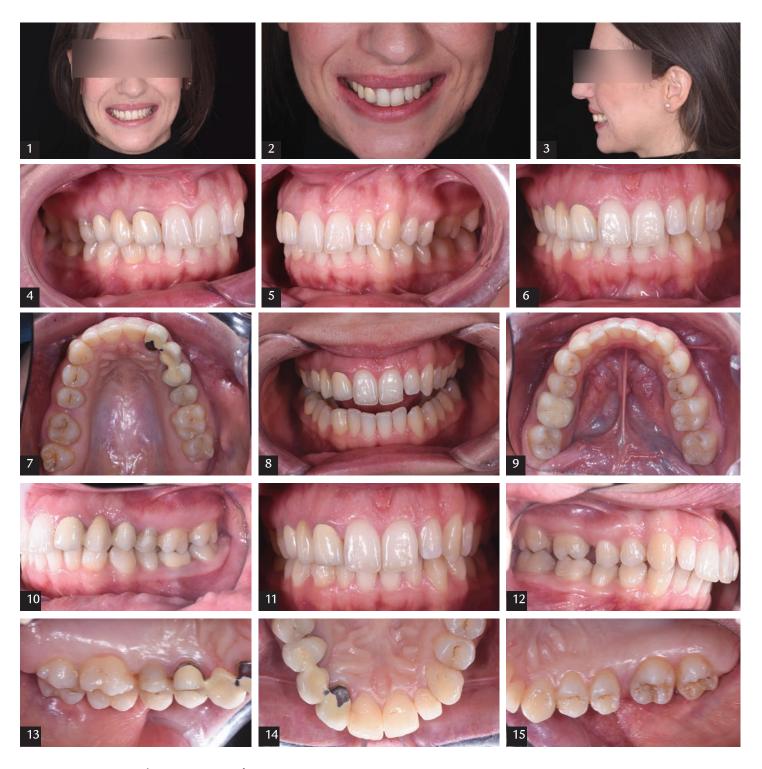
The patient, dissatisfied with her smile, presents herself for examination due to recurrent odontalgia, chewing difficulties and to remedy the exposure of the metal margins of her existing crowns which are apparent when she smiles (Figs. 1 to 3).

We appreciate the presence of prosthetic crown & bridge that are inadequate in terms of shape and proportion and are resulting in masticatory discomfort for this patient.

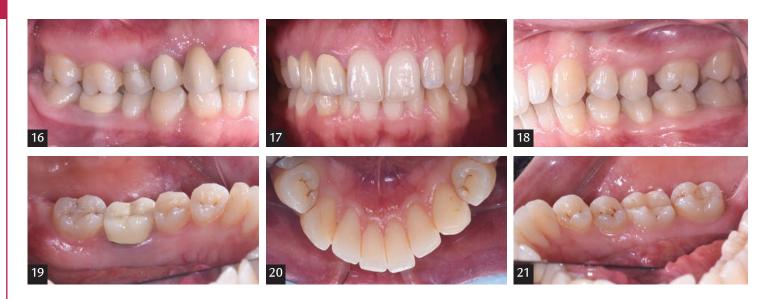
Details of the occlusal table of the maxillary prosthetic crown & bridge and inadequate lower anatomy, in the presence of chipping in functional areas and conservative failing restorations in both arches (Figs. 7 to 9).

The presence of bacterial plaque is highlighted on the lingual aspects of the lower arch and in failing conservative reconstructions that are worn (Figs. 16 to 21).

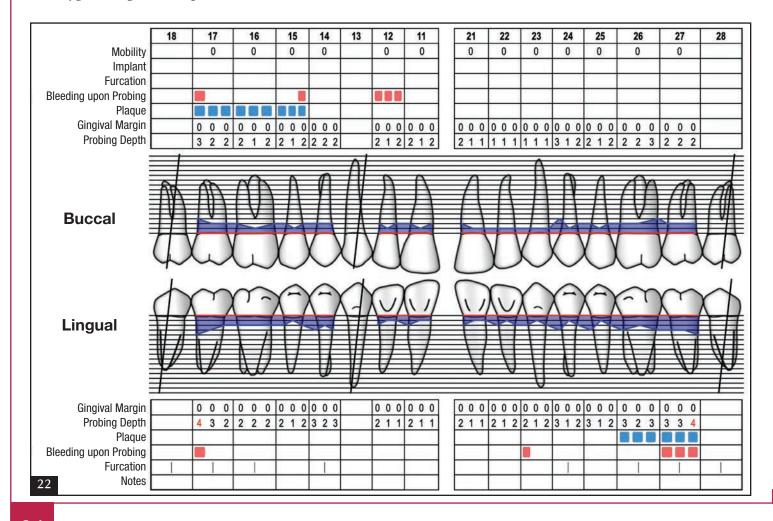
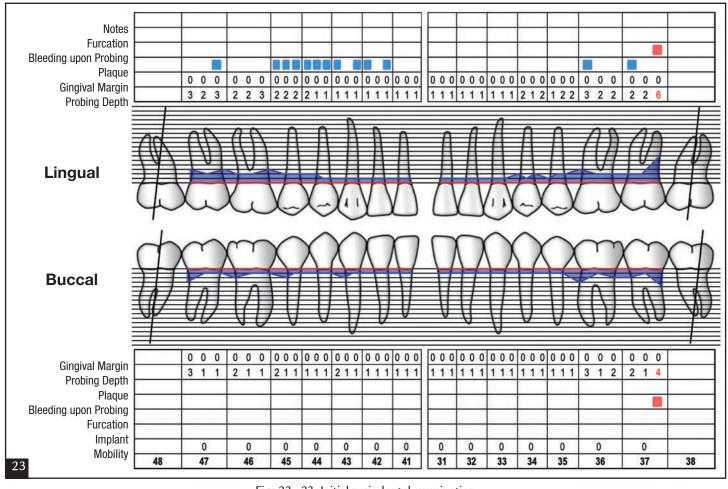
Figs 22 - 23: Initial periodontal examination

Marginal gingivitis with the presence of bacterial plaque and bleeding are at the level of the prosthetic crowns and on the lingual sides of the mandibular arch. After hygiene therapy, education and motivation for oral hygiene, a general improvement in plaque indexes and gagging were found, despite the patient have difficulty maintaining hygiene due to the horizontal over contour and failing margins of previous prosthetic reconstructions.

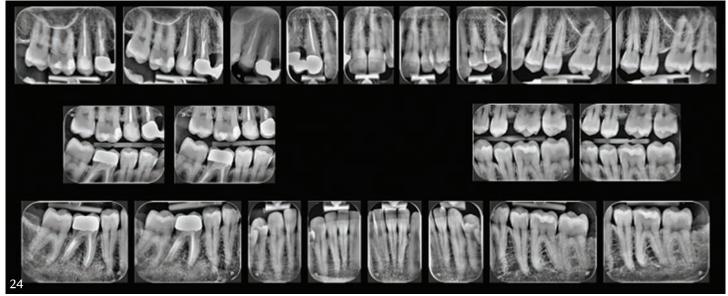
Fig 24: Complete radiographic status

The radiographic examination reveals

inadequate endodontic treatment of 15, 14, 12, 46. Note the presence of a ceramic metal bridge from 14-12 (probably made due to the agenesis of the lateral incisor and the ectopic position of the canine in sextant 1). There is a crown on tooth 46 with over-contoured prosthetic margins. The absence of 12 and the position highlight ectopic tooth13.

There are conservative composite restorations in teeth 16, 17, 27, 35, 36, 37, 45 and 47. Previous odonto-prosthetic restorations create functional discomfort for the patient in static occlusion and interferences in mandibular dynamics. A Class II

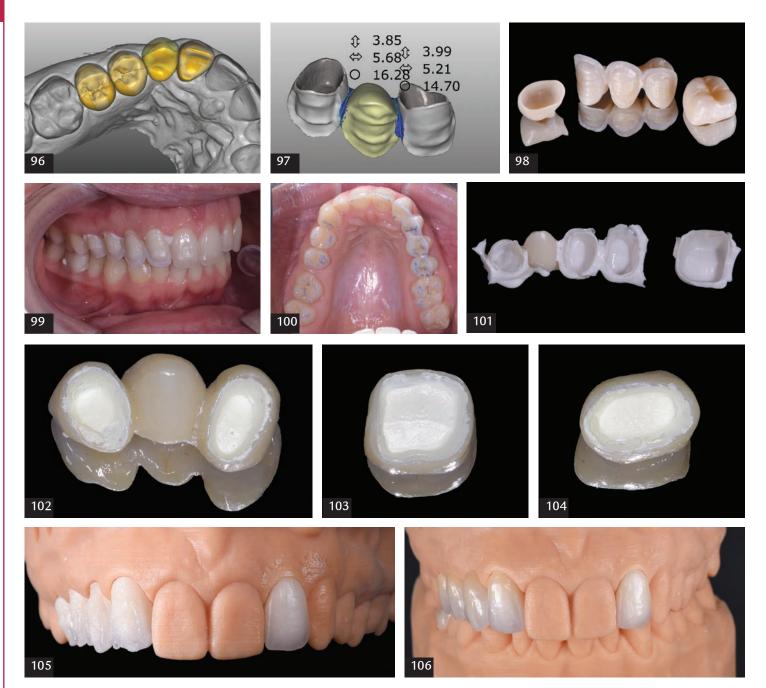
The digital impressions of the temporaries were taken of the upper and lower arches and bite registration of the patient in static position. Subsequently, the habitual occlusion was recorded between the model with

Thus, it was possible to create the digital cross-mounting and to transfer all functional information and aesthetics that were achieved with the functionalized provisional (Figs. 92 and 94).

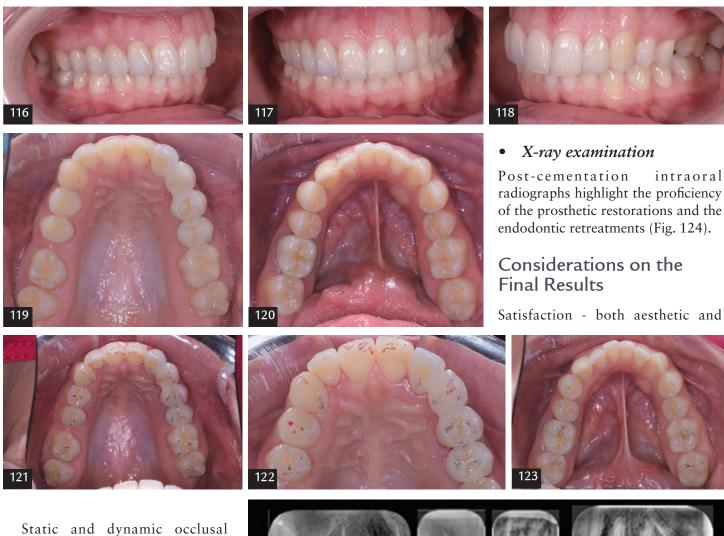
The integration and naturalness of the zirconia ceramic and lithium disilicate restorations is seen both at the tissue and dental levels (Figs. From 116 to 118).

Occlusal and anterior aspects of the final prosthetic reconstruction (Figs. 119 and 120).

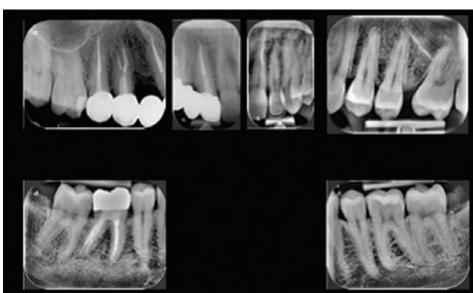
Fig 124: Final radiographic examination

The absence of symptoms and the restoration of masticatory function with fixed restorations made of partially layered zirconia ceramic and layered lithium disilicate are an expression of stomatognathic rehabilitation integration on natural roots

The excellent integration of prosthetic rehabilitations confirmed the periodontium with plaque indices 15% lower and bleeding indices less than 10%.
